**SUMMARY**  
 5303 46th Ave SW, Seattle, WA 98136  
 Bryan Bentrott  
 May 29, 2023

Jens Stolsig  
 WA Inspector #22004108  
 Titan Inspection Services  
 206-451-1120  
 info@titaninspectionsservices.com

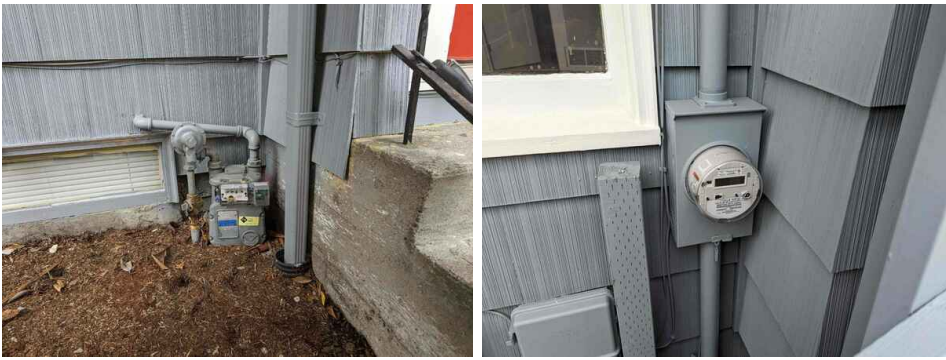
1.4.1 Utilities  
**METER INFO**

Here is your utility meter info.

Recommendation  
 Recommend monitoring.

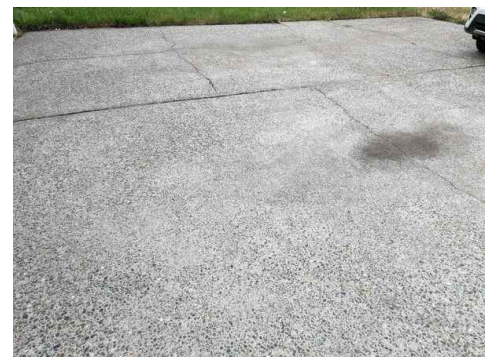
The driveway is in good shape at this time. Recommend regular care and maintenance to keep any standing water off and away from the driveway.

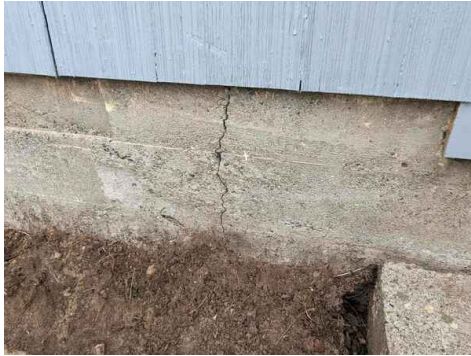
#### **FOUNDATION CRACKS - MINOR**

Minor cracking was noted at the foundation. This is common as concrete ages and shrinkage surface cracks are normal. Recommend monitoring for more serious shifting/displacement. Making sure any water that comes from the gutters or possible hydro static water pressure (water pushing up from the ground) is directed away from the foundation is really important.

**\*Recommend sealing any foundation cracks with epoxy on houses with finished basements. Sometimes basements get finished on the inside and the concrete walls are not properly sealed. It's always a good idea to seal any cracks to impede any water from getting in when it rains.**

Contact a handyman or DIY project

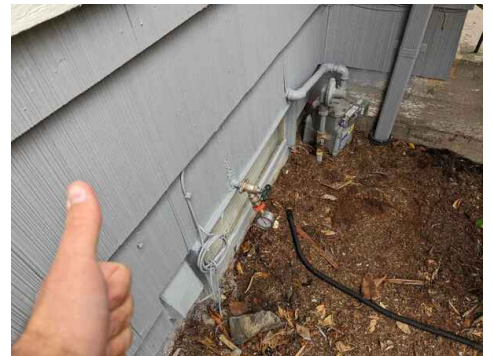
At the time of the inspection the spigot(s) were functional.

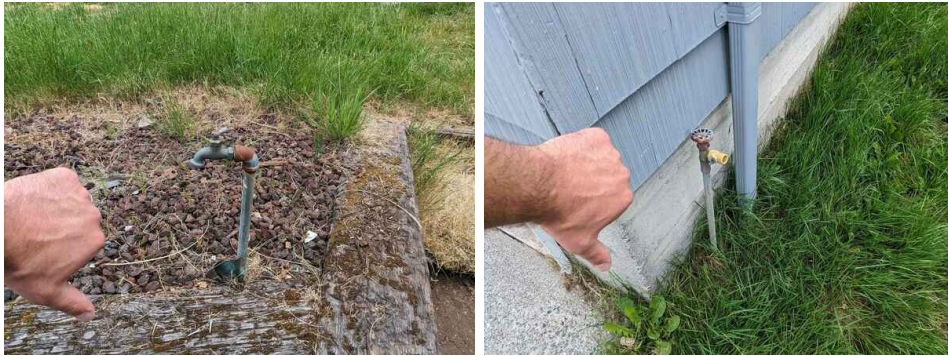
The exterior faucet was inoperable. It may be turned off inside or it may need to be replaced. Recommend further evaluation and repair as needed.

Contact a qualified plumbing contractor.

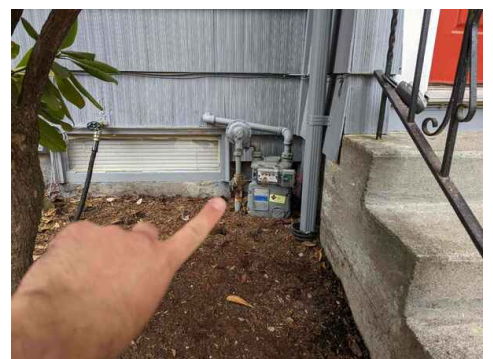
### 3.10.1 Gas fuel Lines

## GAS FUEL LINE PIPING IS STARTING TO RUST

Recommend painting with rust inhibiting paint to prevent holes from developing.

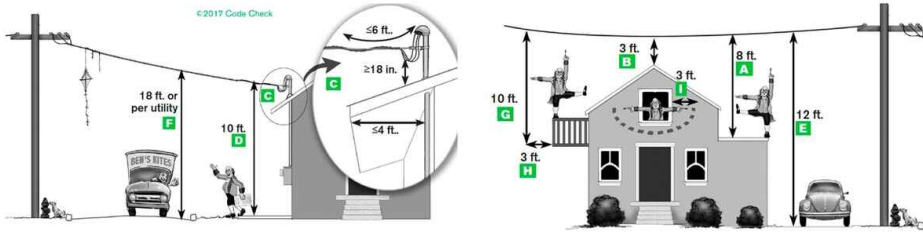
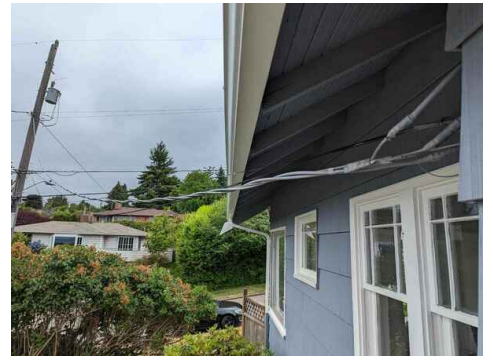
### 3.11.1 Electrical Service Wires

## ELECTRICAL SERVICE WIRE DOES NOT HAVE THE PROPER CLEARANCE

In general overhead service conductors must maintain a minimum vertical clearance of 8 feet above the surface of the roof for a minimum distance of 3 feet in all directions from the edge of the roof. See other clearance requirements in the images attached.

Recommendation  
Contact a qualified electrical contractor.

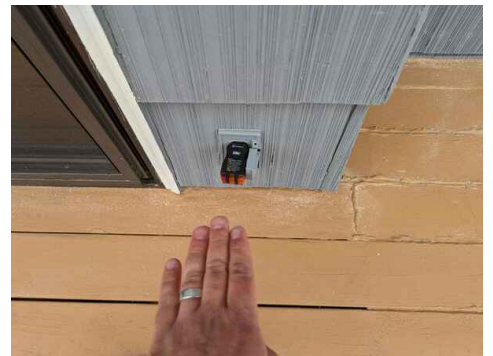
Current standard is for exterior plugs to be GFCI protected.  
Recommend installing a GFCI plug on any exterior plug circuits.

Recommendation  
Contact a qualified electrical contractor.

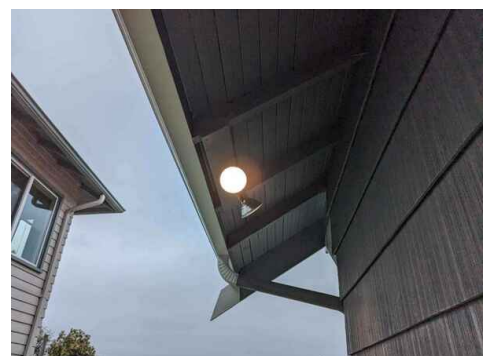
The exterior lighting is in good condition at this time.

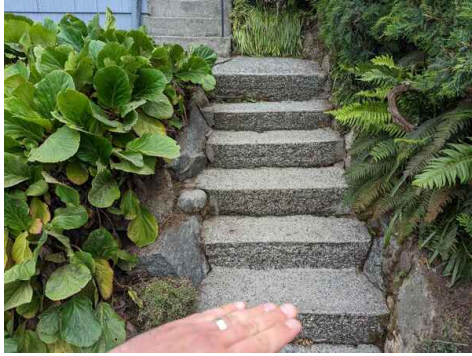
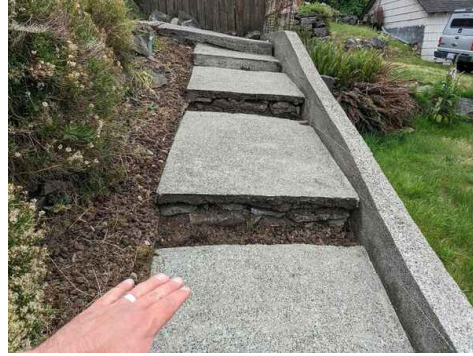
### CONCRETE WALKS/PORCH HAVE SETTLED

This is common if the concrete was poured on an improperly prepped surface, or it was not properly attached to the house with rebar. Recommend monitoring.

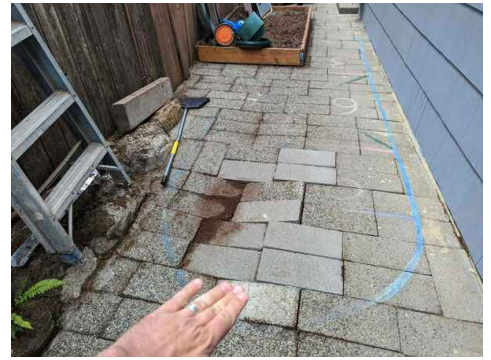
#### 4.1.2 Walkways & Porch

### WALKWAY PAVERS HAVE SETTLED

It is common for pavers to settle over time. Recommend removing the pavers that have settled, adding sand and resetting them level with the surface that has not settled.

Contact a handyman or DIY project

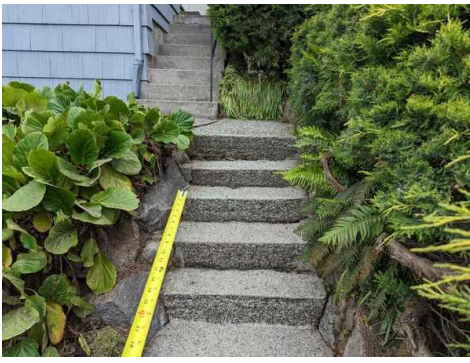
The stairs are functional but can pose a trip hazard when they are different sizes. The standard stair height should be 7 3/4" and they should all be within 3/8" of each other. Just wanted to make you aware.

Contact a qualified professional.

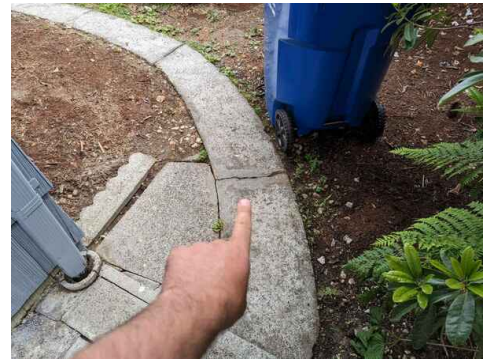
### CRACK IN CONCRETE PATH OR STEPS

Recommend sealing cracks with Portland cement as needed.

Contact a handyman or DIY project

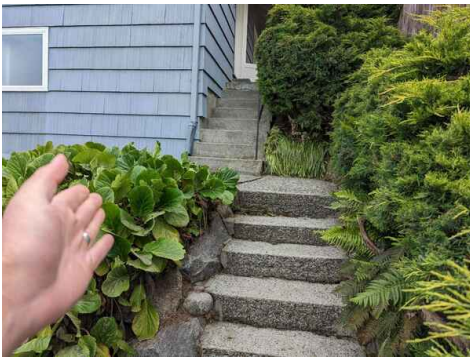
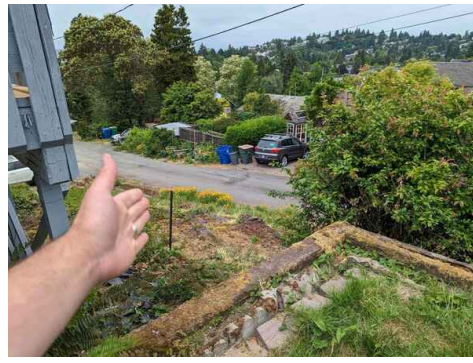
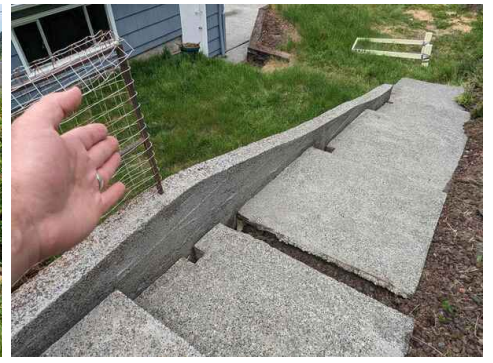
### NO RAILING

It is recommended to have a railing on any deck over 30" off the ground and/or 3 or more stairs.

Contact a qualified professional.

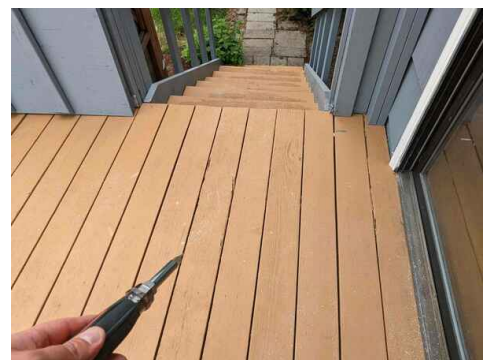
4.5.1 Decking Boards  
**DECKING - ROTTED BOARDS**

One or more deck boards are showing signs of rot. Recommend replacing as needed.

Recommendation  
Contact a qualified deck contractor.

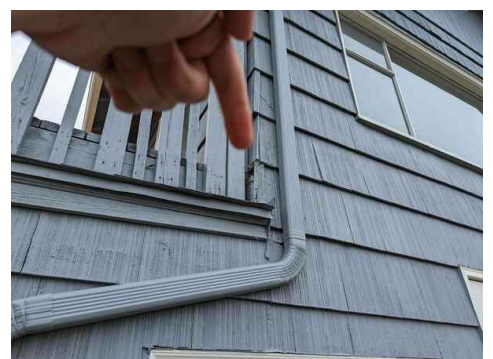
4.7.1 Deck Ledger against house  
**DECK LEDGER - IMPROPER FLASHING AND WATERPROOFING**

The ledger or deck connection to the house does not have a proper flashing or waterproofing measures. This can rot out the siding underneath it over time and/or the ledger that attaches the deck to the house. In some cases the roof soffit overhang is enough to protect this area from water, but not always.

The best alternative is to properly install drip edge flashing that kicks the water out from this area and protects the house siding. This needs to be properly installed by a competent person that understands the application.

Recommendation  
Contact a qualified professional.

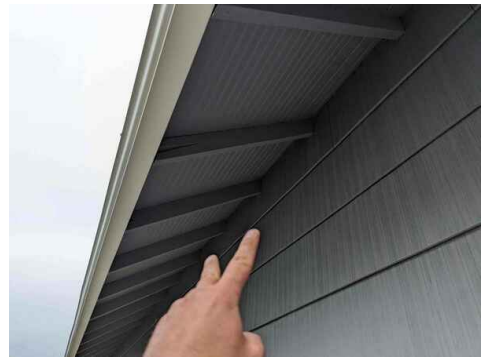
5.1.2 Eaves/Soffits  
**COULD USE MORE SOFFIT VENTILATION**

Recommend adding some additional soffit vents for good cross ventilation.

Recommendation  
Contact a qualified handyman.

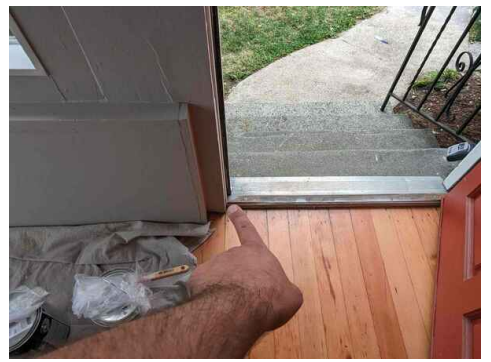
5.2.3 Exterior Doors/Hardware  
**WEATHERSTRIPPING MISSING OR NOT THICK ENOUGH**

Recommend installing the proper weatherstripping for the door and setting the latch so the door presses against the weatherstripping. Having the door properly sealed will prevent air movement through the opening.

Recommendation  
Contact a handyman or DIY project

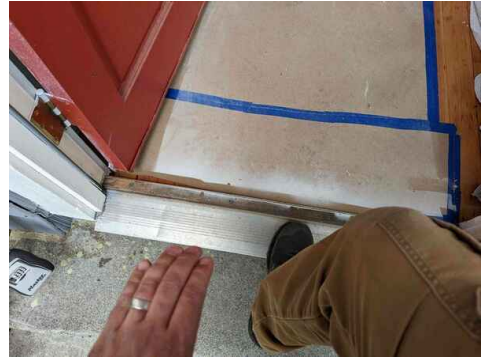
#### 5.2.4 Exterior Doors/Hardware **EXTERIOR DOOR THRESHOLD NEEDS SUPPORT**

The threshold has some deflection when you step directly on it. This will break down the base of the door frame over time. Recommend adding support under threshold for the door to preserve the overall life and function of the door.

Recommendation  
Contact a handyman or DIY project

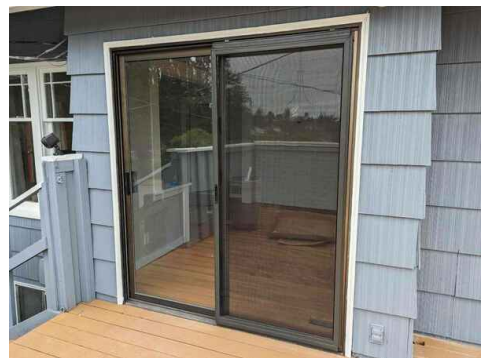
You may want to spray some silicone on the track for the screen door to slide easier.

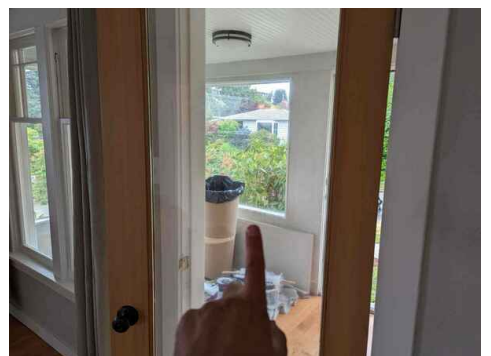
#### 5.5.1 Windows **WINDOW APPEARS TO HAVE A BROKEN SEAL**

I noticed a window with a broken seal. You can either replace the glass in the window frame or replace the whole window and frame. Most commonly the double paned glass is what is replaced. You can also just leave them the way that they are they are just a bit less energy efficient.

Recommendation  
Contact a qualified window repair/installation contractor.

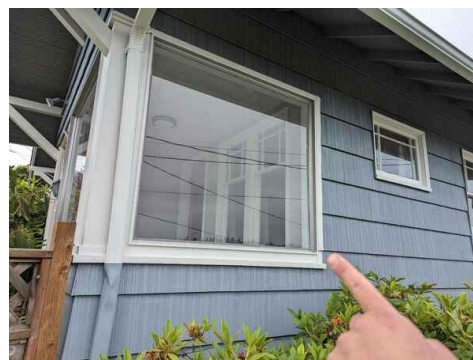
#### ALUMINUM WINDOWS/SLIDER

Aluminum windows and sliders are not as efficient as the new vinyl windows. They are functional at this time. I just wanted to make you aware of this.

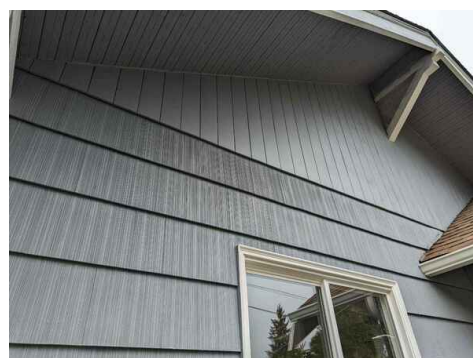
The siding is in good condition at this time.

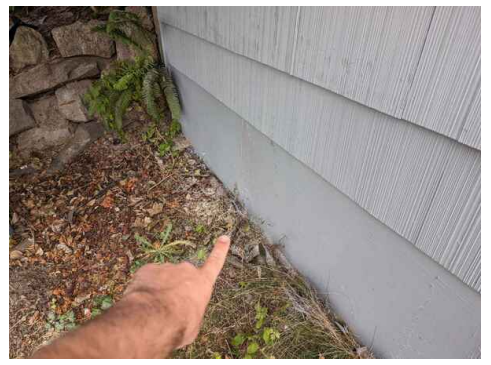
Inadequate clearance between siding and the ground or hard surface. A minimum ground clearance between bottom of siding and ground of 4", for hardscapes a 2" clearance is recommended. **Siding in contact with the ground or soil is a concern because it can provide direct access for wood destroying insects and or moisture.** This will affect the siding's ability to dry out after it rains as well. The key is to give the siding some clearance so that it can drip dry and not remain wet for an entire season or all year long even. It is also recommended to have a 2% grade to help drain any surface water away from the house as needed.

Recommendation  
Recommended DIY Project

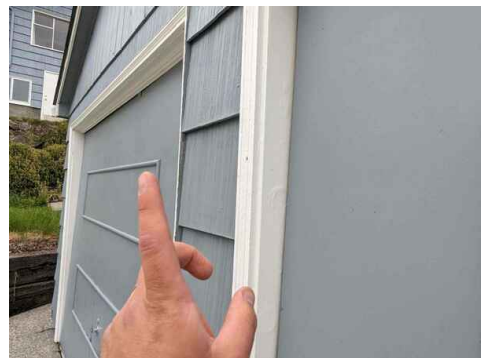
#### **SOME PAINT IS CRACKING, FLAKING OR BUBBLING**

The paint is flaking or bubbling in spots. This is or will expose the bare wood siding and trim. I recommend proper scraping, primer and re-paint to preserve the life of the siding and trim.

Recommendation  
Contact a qualified painting contractor.

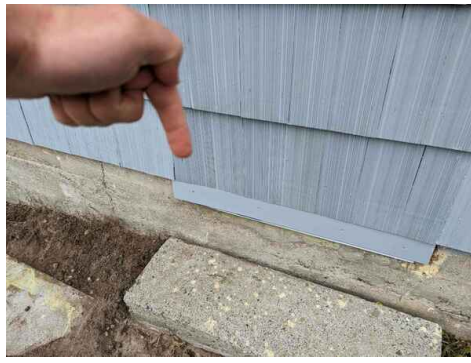
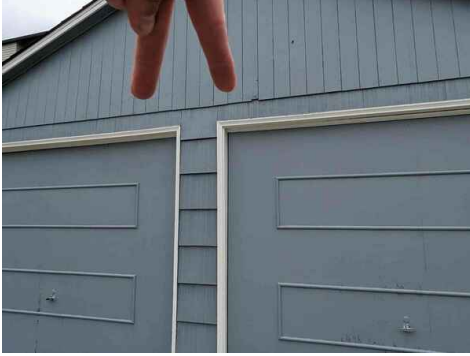
#### **FLASHING - MISSING**

There are areas that I recommend installing flashing to protect the home properly.

Recommendation  
Contact a qualified professional.

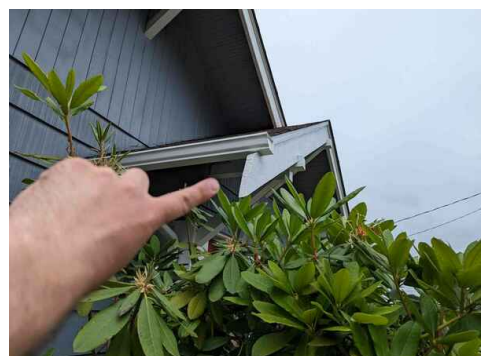
### 5.10.2 Fascia and Trim **FASCIA TAILS ARE EXPOSED**

This is common, but it is a good idea to protect these facial tails with roofing so that they don't deteriorate prematurely and would need to be repaired or replaced. Adding a small piece of roofing or flashing extended beyond the tail end by 1 1/2" would do the trick. I also recommend scraping, caulking, applying primer and re-painting with a quality paint. It is also going to weather more quickly in these areas and may need additional painting over time.

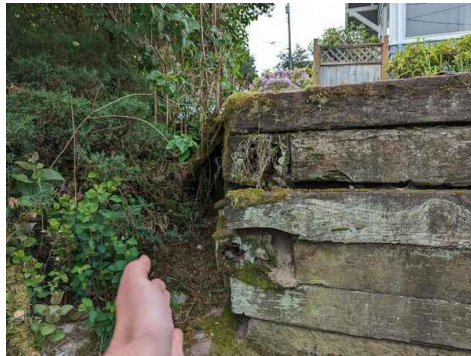
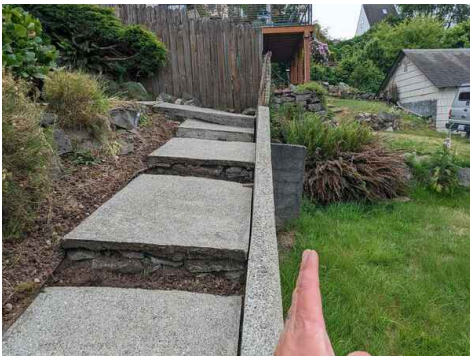
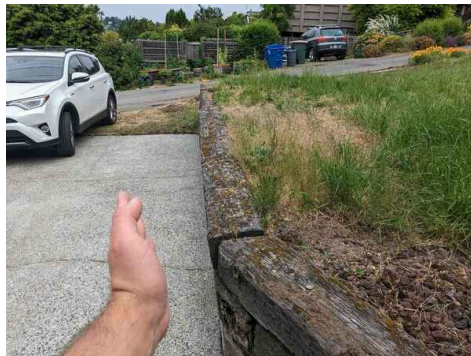
Retaining wall is failing. Recommend qualified contractor to repair.

Recommendation  
Contact a qualified landscaping contractor

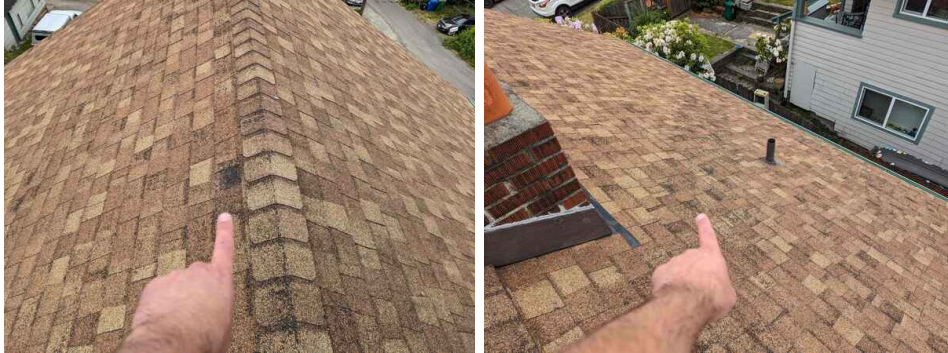
**SHINGLES OVERLY WORN**

A few shingles are damaged/missing and/or the roofing is worn in some spots. I recommend replacing and or repairing as needed. The roof appears to not be leaking at this time.

Contact a qualified roofing professional.

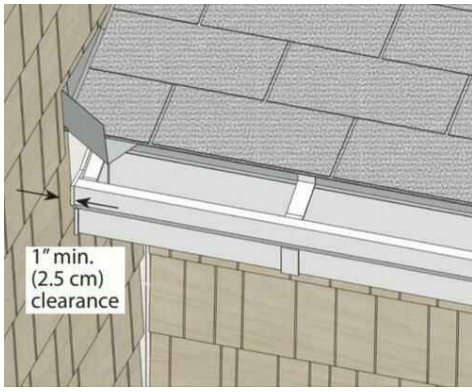
The home had no kick-out flashing installed in some or all areas where it is needed. Kick-out flashing is designed and installed to divert water from behind the exterior wall covering at areas of the home where a sidewall extends out past a connecting roof eave. This condition may allow moisture intrusion of the exterior wall covering. Moisture intrusion of the wall structure can damage home materials and encourage the growth of mold. Long term moisture intrusion can cause structural damage from wood decay.

Contact a qualified roofing professional.

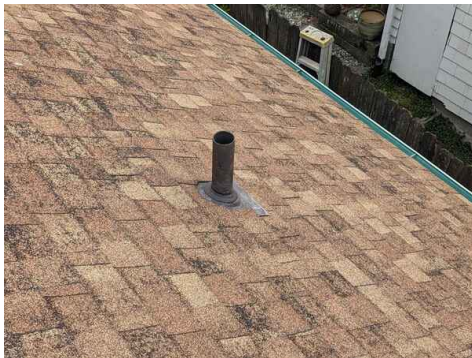
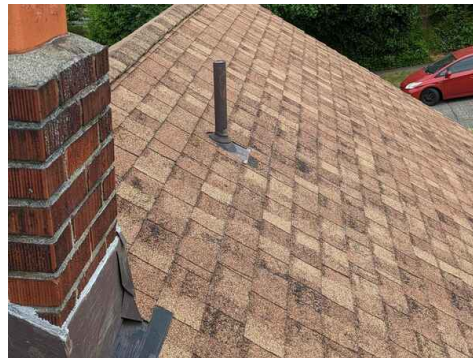
Plumbing and ventilation boots appear to be in good shape at this time from what I can see.

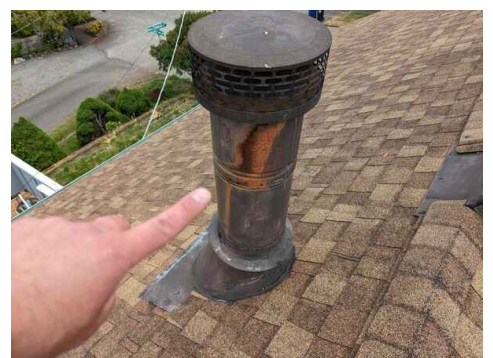
### 7.8.2 Plumbing and Combustion Vents

## COMBUSTION VENT IS RUSTING

Recommend painting in the short term and eventual replacement.

Contact a qualified professional.

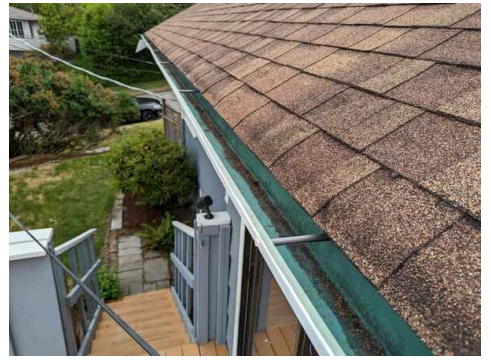
7.10.1 Gutters  
**GUTTERS - OK**

Gutters are in good shape at this time. Recommend keeping an eye on the gutters and cleaning as needed if you have trees in the area that may drop debris in them.

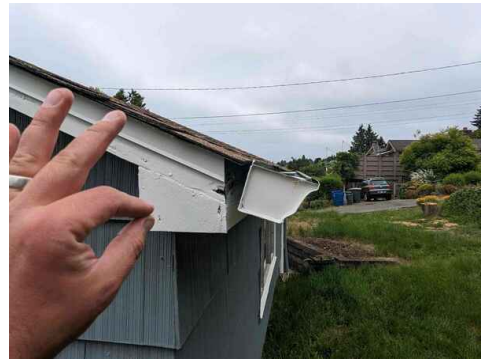
7.10.2 Gutters  
**GUTTER LOOSE OR NOT PROPERLY ATTACHED**

Garage.

Recommendation  
Contact a qualified handyman.

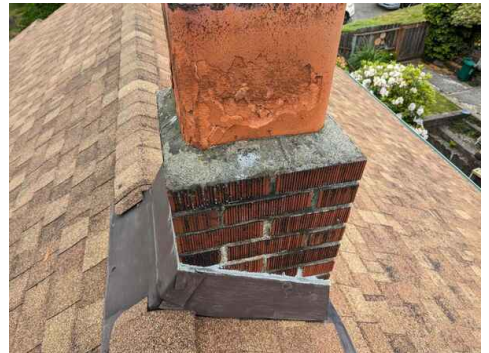
7.16.1 Chimney Cap

**CHIMNEY - NO CAP/SPARK ARRESTOR**

The chimney(s) had no spark arrestor. I recommend that all chimneys have an approved spark arrestor installed by a qualified contractor to prevent pest entry and to help protect the roof-covering materials from potential chimney-source ignition.

Recommendation  
Contact a qualified professional.

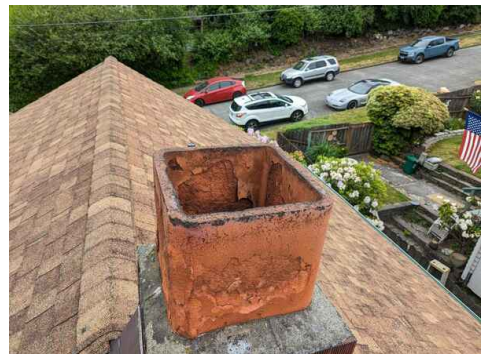
7.17.1 Chimney flue  
**CHIMNEY UNLINED**

Chimney was unlined with the furnace venting into it, which can deteriorate the chimney structure and allow harmful gasses to enter home. Recommend a qualified masonry or chimney contractor evaluate and remedy if you want to get the chimney lined.

Recommendation  
Contact a qualified heating and cooling contractor

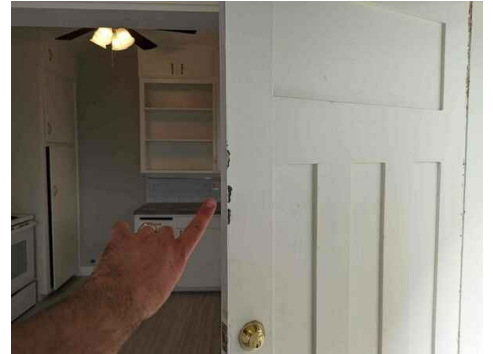
8.13.1 Cabinets

The cabinets are in good shape at this time relative to their age, quality and care.

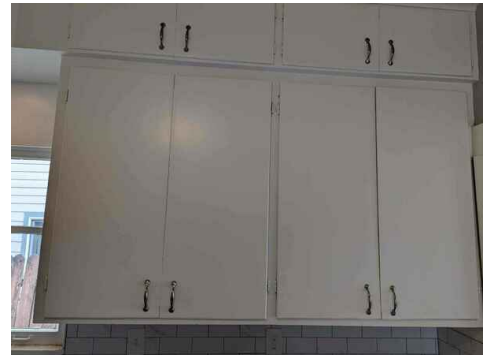
8.13.2 Cabinets

**CABINETS NEED ADJUSTMENT**

Recommend adjusting drawers, doors or shelves as needed.

Recommendation  
Recommended DIY Project

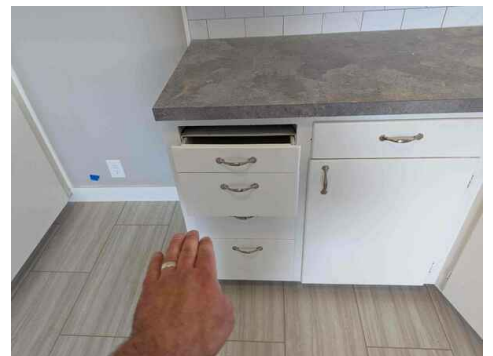
8.14.1 Countertops

The countertops are in good shape at this time relative to their age, quality and care.

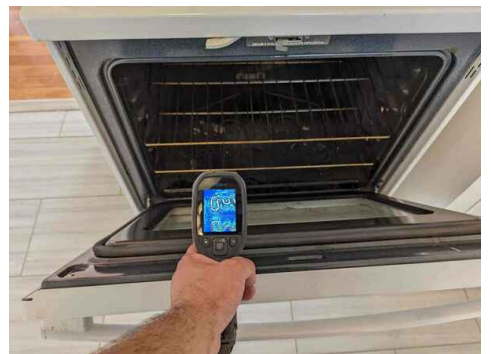
### 9.3.2 Oven/Cooktop

The cooktop appears to be in good working condition at this time.

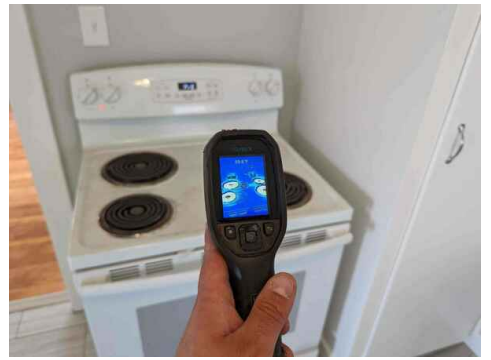
### 9.3.3 Oven/Cooktop

Range was not fastened to the floor. This poses a safety hazard to children. Recommend a qualified contractor secure range so it can't tip.

Contact a handyman or DIY project

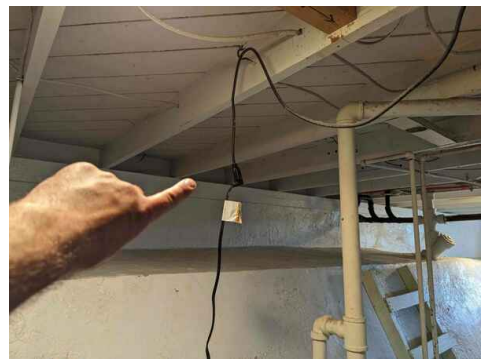
#### 10.1.1 Main Water Shut-off Device

Recommend testing the water shut-off periodically for proper operation.

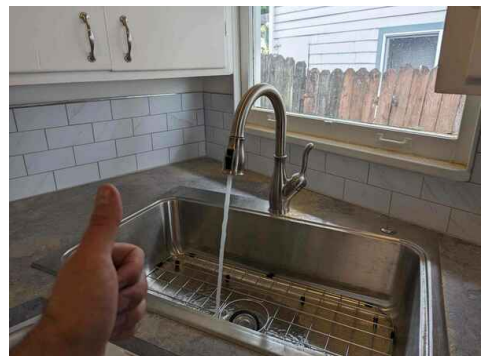
#### 10.3.1 Hammer Valves

I recommend installing hammer valves for any mechanical item tied to the water supply lines. This will reduce the stress on the water lines over time with these items turning on and off all the time. It is not a requirement, but rather a good idea.

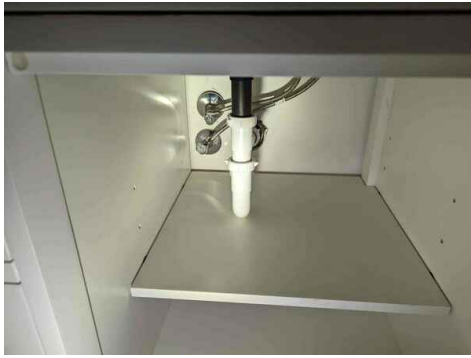
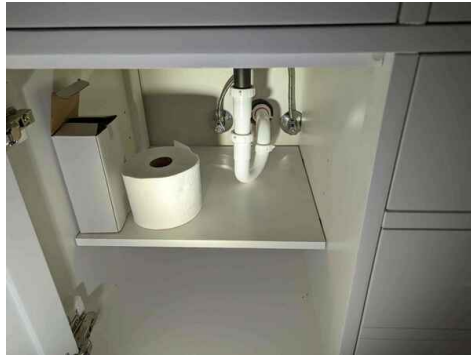
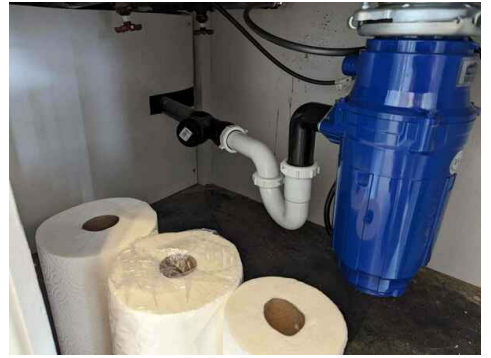
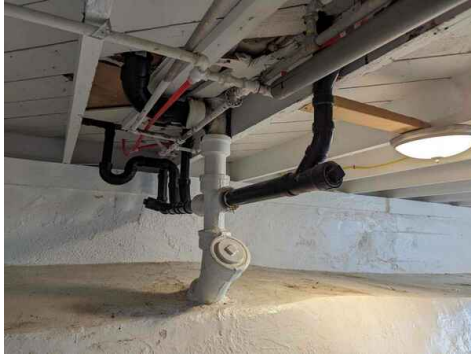
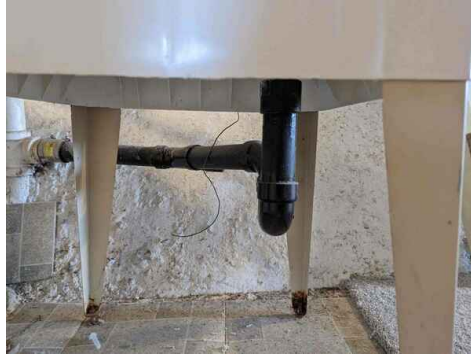
The drains and vents for sinks appear to be properly installed under the sinks. I ran the hot and cold water and everything appeared to run correctly at this time.

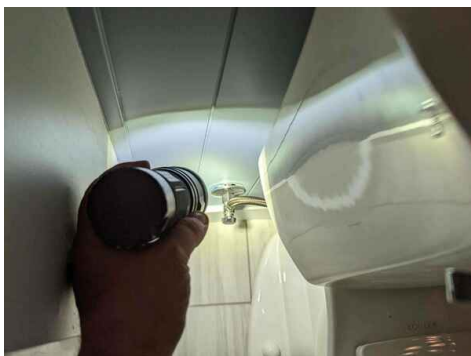
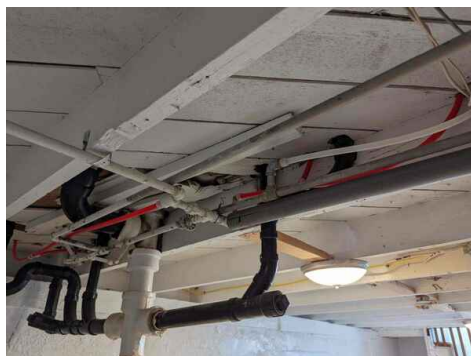
#### 10.6.1 Water Piping **WATER LINES ARE OK**

I did not see any visible leaks or major problems at this time. Keep an eye on the plumbing under the sinks periodically to make sure everything is ok.

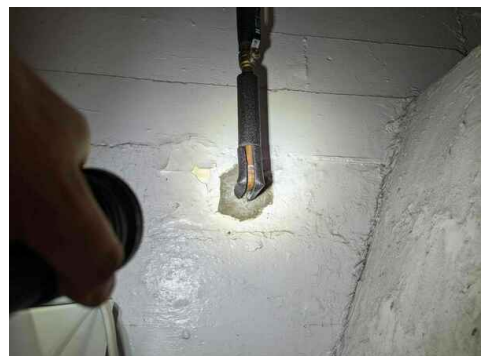
#### 10.6.2 Water Piping **WATER PIPE LEAKING**

A water pipe is leaking. Recommend a plumbing contractor evaluate and repair as needed.

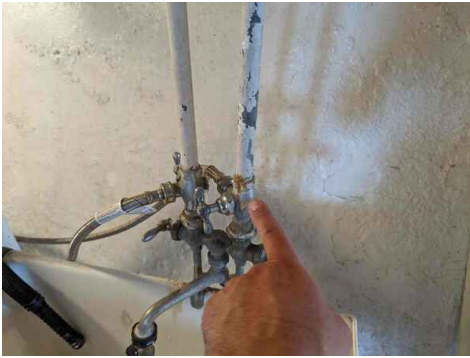
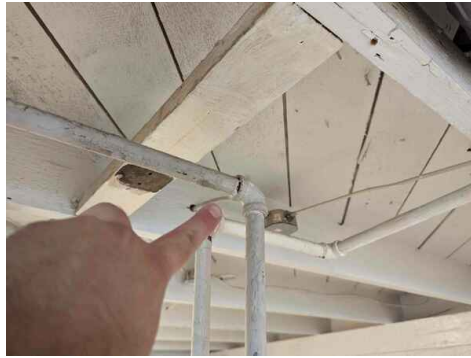
### 10.6.3 Water Piping **SIGNS OF A PAST LEAK**

It appears that one of your water supply stop valves was leaking. It was not leaking at the time of the inspection but recommend monitoring and if it starts to leak, replacing the valve.

Recommendation  
Recommended DIY Project

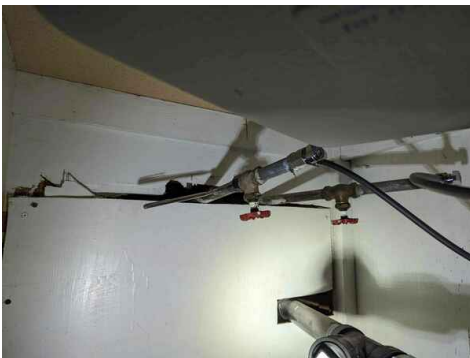
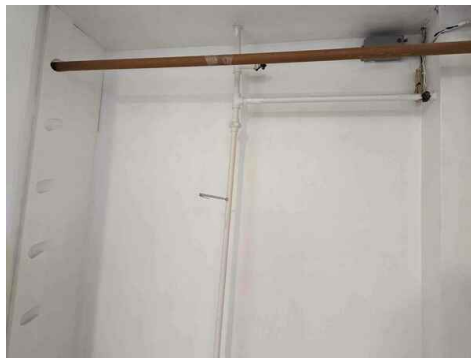
### 10.6.4 Water Piping **GALVANIZED PIPING - WILL NEED REPLACING OVER TIME**

Galvanized piping will rust and plug up over time. It will eventually need to be upgraded.

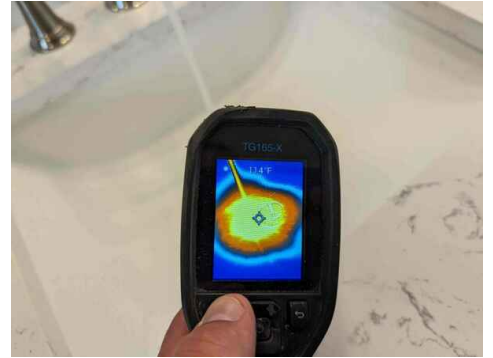
## WATER TEMPERATURE PICTURE

The standard temperature is 120 degrees.

\*I do not recommend having the water temperature set to over 135 degrees and with small kids or elderly people, I would turn it down even lower.

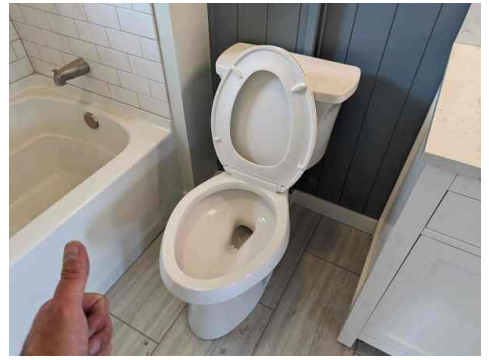
10.10.1 Toilets  
**TOILETS - OK**

Toilets were working ok at time of inspection.

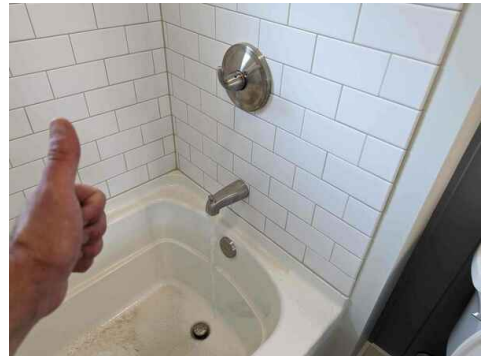
10.12.1 Tub Controls  
**TUB CONTROL VALVE - OK**

Tub valve was functioning ok at this time.

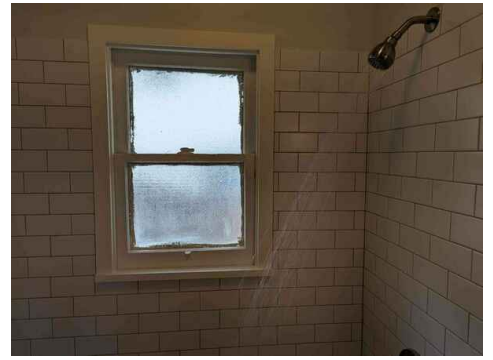
Windows are not really a good idea in a shower but if you have them they need extra attention and to be sealed properly. Recommend monitoring and sealing as needed.

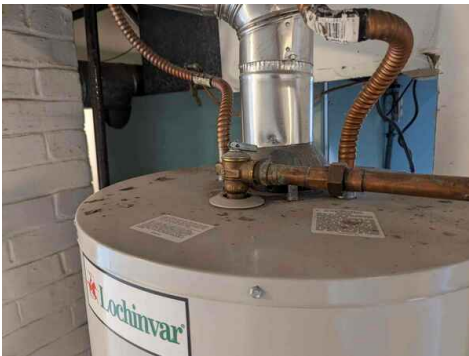
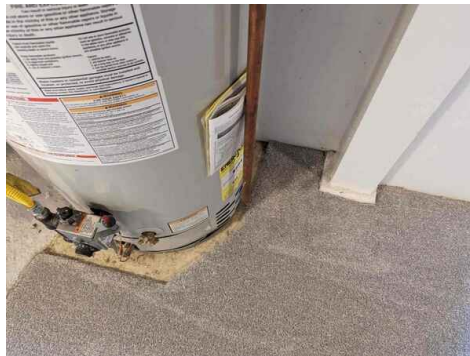
10.19.1 Water Heater - Pressure and Temp Relief  
**PRESSURE AND TEMPERATURE RELIEF - OK**

The pressure and temperature line is not supposed to leak any water unless there is a problem that needs to be addressed. If you ever see water coming out of the water heaters pressure and temperature relief drain line, contact a qualified technician to come take a look.

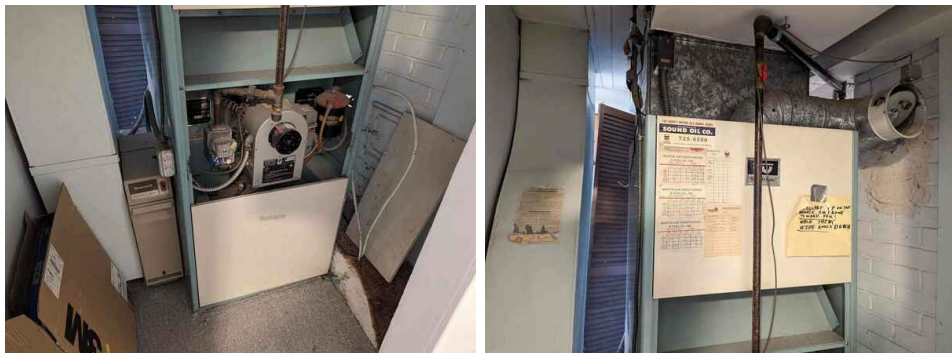
11.1.1 Heating System  
**FURNACE - OK**

The furnace or heating system appears to be in good working condition at this time. It is always a good idea to have a certified heating contractor or electrician take a look at the equipment periodically. It is also a good idea to get the furnace serviced when buying a house.

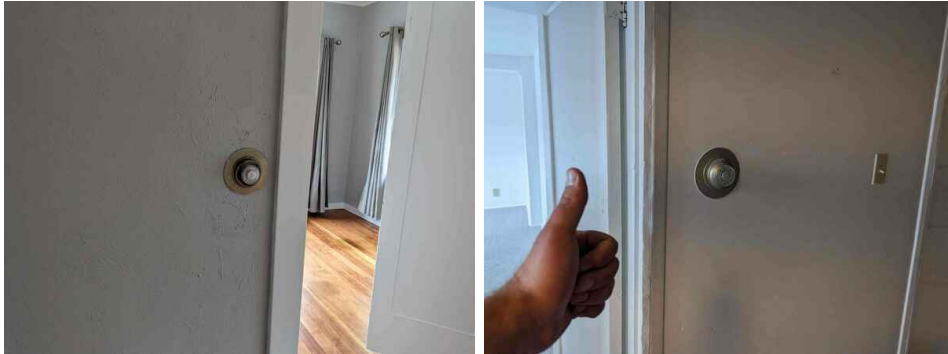
### 11.3.1 Thermostat

The thermostat is working at this time.

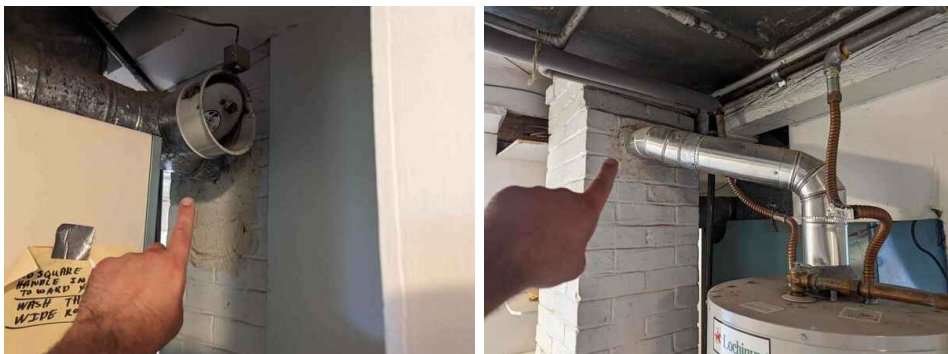
Exhaust flue from furnace/water heater vents into chimney. This was common years ago. Today, it is recommended that we install a chimney liner in order to protect the inside of the chimney itself from deteriorating. I recommend a qualified HVAC contractor to take a look.

Contact a qualified heating and cooling contractor

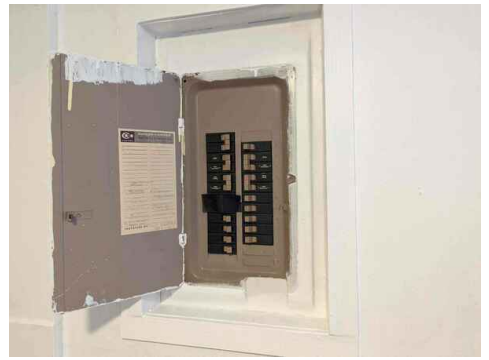
**PANEL - OK**

The electric panel appears to be operational at this time.

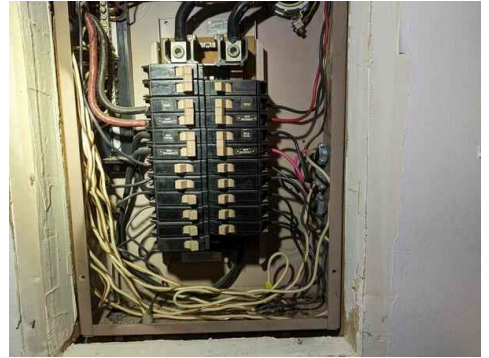
**BRANCH CIRCUIT WIRING - OK**

I found no issues with branch circuit wiring at the panel or throughout the home that I can see.

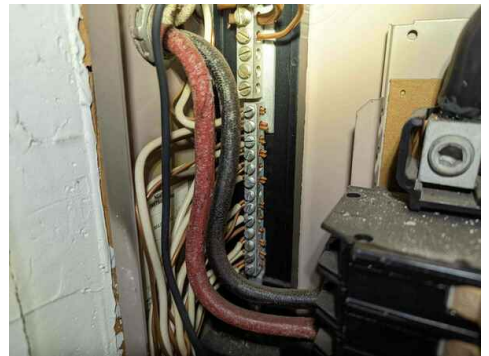
**MORE THAN ONE NEUTRAL OR GROUND WIRE IS SECURED UNDER ONE LUG**

Each neutral (white, grounded conductor) wire should be secured separately under its own lug/set-screw terminal in an electric panel, per National electrical Code (NEC 408.41). This was done commonly back in the day. It is recommended to make sure they are a secure connection when the wires are heated up and cooled down over the life in the panel.

Contact a qualified electrical contractor.

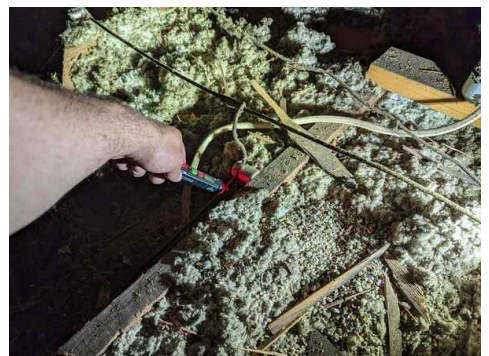
It is common to have knob in tube wiring in older houses from the late 1800s to the 1940s. There is not necessarily a reason to remove it but note that homeowners insurance may be harder to get if you have knob and tube wiring but it is available. Recommend discussing with your agent. This wiring is gradually getting phased out of houses over time.

It is also important to not have insulation covering it as this can cause the wiring to overheat. Recommend ensuring that all knob and tube wiring be free of insulation.

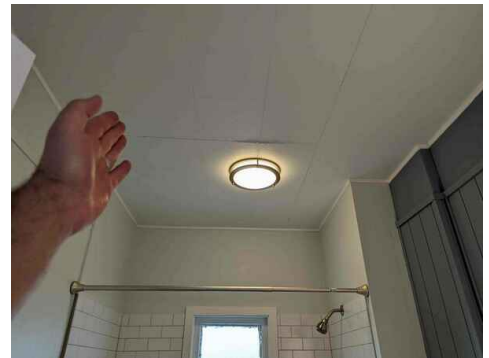
**THE HOUSE HAS SOME ACTIVE KNOB AND TUBE WIRING**

Contact a qualified electrical contractor.

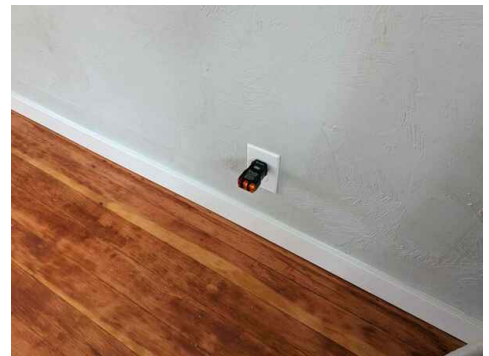
Overall, the plugs that I was able to test were working fine at this time. Its always a good idea to make sure you replace any damaged cover plates if they break, replace any plug that becomes loose and does not hold your cord in tightly and make sure everything remains tight and secure in the electrical box for the plug. If ever you see what looks to be a burn mark on a plug, that is not a good thing. It would be a good idea to have an electrician look at your system or if you know you did something that made the plug pop and created that burn mark to replace the plug.

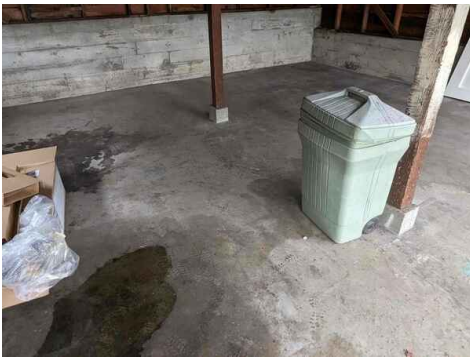
No signs of large cracks, settling or major stains on the concrete floor at this time. It is not uncommon to see some cracking of slabs. You want to watch for cracks that are greater than 1/4" wide or have a height differential. You have neither at this time.

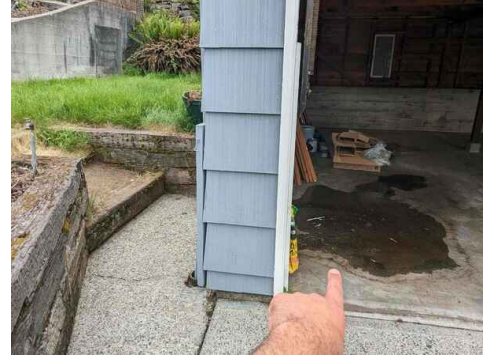
#### **PUDDLE**

There was water on the garage floor at the inspection. The seller's agent reports having pressure-washed the walkways the day before. Recommend monitoring the drainage in this area during and after a rain, and diverting water away from the garage as needed.

Recommendation  
Recommend monitoring.

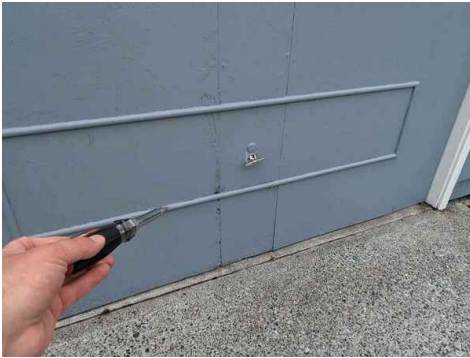
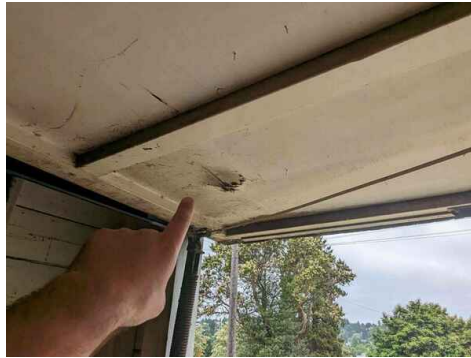
#### **PANEL DAMAGE**

Garage door panel is damaged. Recommend a qualified garage door contractor evaluate and repair if you deem necessary.

Recommendation  
Contact a qualified garage door contractor.

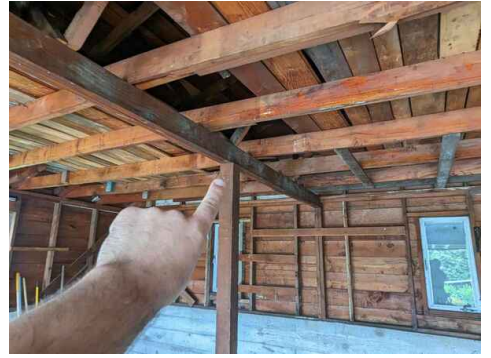
13.7.1 Roof framing (Detached Garage)  
**RECOMMEND POSITIVE CONNECTING  
HARDWARE THROUGHOUT**

This will strengthen the roof framing.

Recommendation  
Contact a qualified professional.

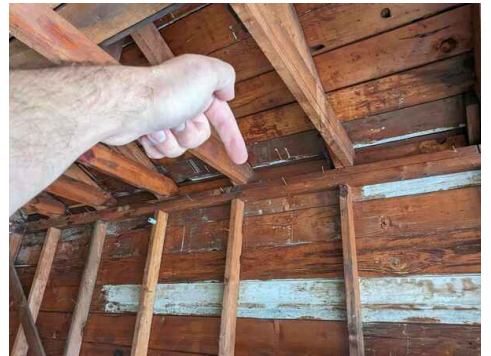
13.7.3 Roof framing (Detached Garage)  
**THE SIDES OF THE ROOF RAFTERS ARE NOT  
HELD DOWN WITH HURRICANE CLIPS**

This is not uncommon with houses built in this era. It also has functioned fine for all of these years. I recommend installing hurricane clips.

Recommendation  
Contact a qualified carpenter.

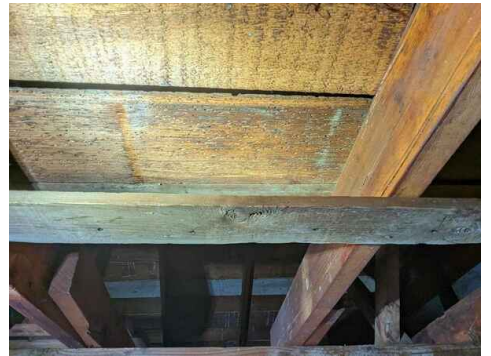
13.7.4 Roof framing (Detached Garage)  
**RECOMMEND A STRUCTURAL PEST  
INSPECTOR**

It is very common to see these markings in older homes in our area. These may indicate wood destroying insects were present in the past. Only a structural pest inspector can identify these and determine if this is an ongoing issue. Recommend having one check this out.

Recommendation  
Contact a qualified professional.

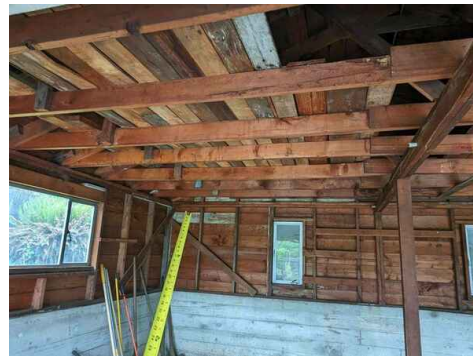
13.7.5 Roof framing (Detached Garage)  
**LONG SPAN**

This span may be too long for these joists. Recommend having a qualified contractor check this out and add more support if needed.

Recommendation  
Contact a qualified carpenter.

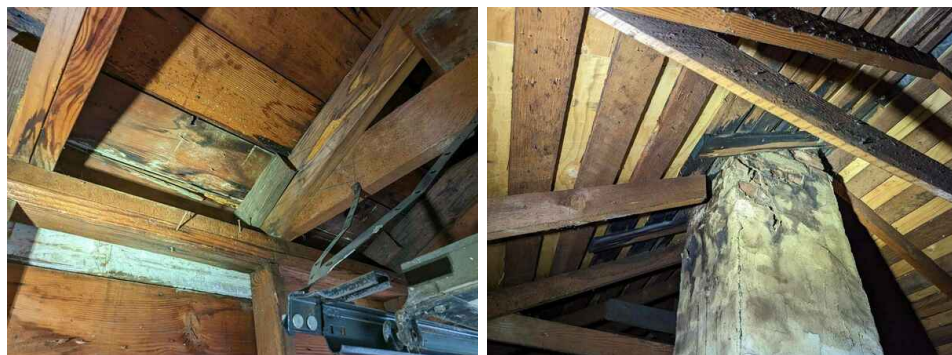
#### 14.3.2 Roof framing and supports **EVIDENCE OF PAST OR CURRENT ROOF LEAK**

Detached garage

Recommend further evaluation and repair by a competent roofer.

Recommendation  
Contact a qualified professional.

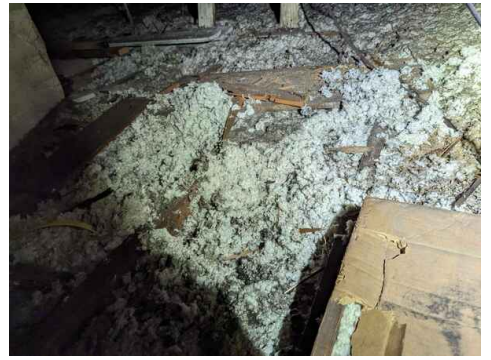
#### 14.4.1 Attic Insulation

I don't think it is necessary to add more insulation at this time unless this is very important to you. I just wanted to make you aware of the attic insulation thickness. Thicker insulation will have the most impact on your heating and or cooling costs. The current energy code calls for R-49, which is about 18" of insulation.

If this is something you wish to do, you can contact an insulation contractor for an assessment and quote. (Just make sure you discuss proper measures to clean up the attic, install any needed ventilation baffles, properly secure any loose wires, make sure all vent connections are mechanically connected and that you properly shroud any electrical fixtures or vent pipes. I would recommend adding any additional ventilation as well.)

Contact a qualified insulation contractor.

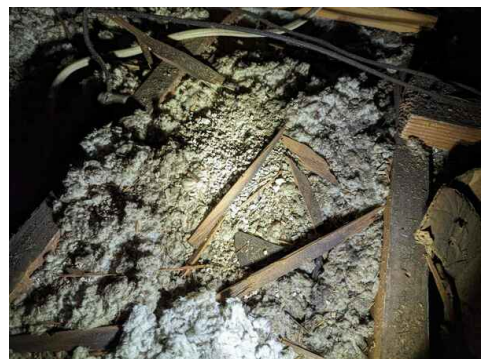
Vermiculite insulation has been known to have traces of asbestos in it. The sellers have furnished a lab report showing negative asbestos presence in a sample consistent with vermiculite.

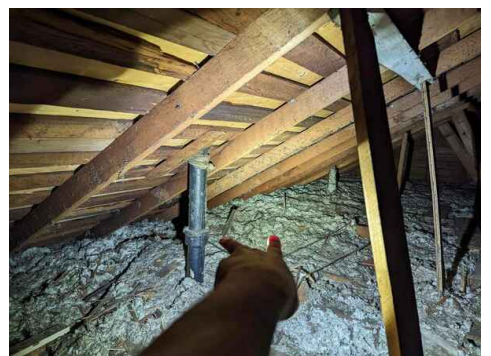
#### 14.5.1 Attic Space Air Ventilation - Soffit/Gable and Ridge Vents

Attic venting was insufficient at time of inspection. Modern standards recommend 1.5 square feet of venting area for every 150 square feet of attic floor space. I recommend an attic contractor or Handyman evaluate and install as needed.

Contact a qualified professional.
